HB9CV-III For Receiving 82.5MHz Built Being Based On The Data By JA1CPA

Manufacturing & Review

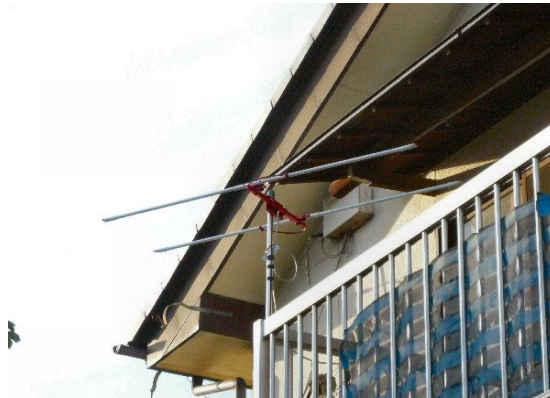
Condition1. Set the phase gap between the radiator and the reflector to 225° , the best value by MMANA (requoted from the site by JA1CPA).

Condition3. The antenna is built on the veranda of the second floor of my house. HB9CV-II is built on the housetop of the three-story building next door. The place is close to a utility pole and power lines that are suspects of strong noises.

I returned to the cut-and-try method. Having notched the ends of elements in units of 5mm in order to read the increased length with sleeves, I set up the antenna provisionally and carried out the adjustment while reading the resonant frequency with a dip meter. The exact element length needed turned out to be **1690mm**. I dismantled it again, fixed the sleeves with bolts, painted and installed it on to the mast to complete as HB9CV-III.

Review: 1. The gain monitored was 56db⁺. It was 47db with HB9CV-I. 2. The tuner monitor showed one simple peak. With HB9CV-II it showed three peaks. 3. Rain, even when it started, it caused no noise nor difference on the monitor. 4. Warning indicator lights occasionally. There seem to be some strong noises other than the power line noises.
